| | AD&C Ltd. | <h2 style="margin: 0;">Service Bulletin</h2> | DoC No: ADxC-28-SB-002 |
| D4 Fascination (VLA) | | | |

| 2.1) Parts/Products affected: | WD4-43-029.A Aileron actuator lever/ spade support arm |

DoC No: ADxC-28-SB-002
Issue: A
Date: 26-Mar-2015

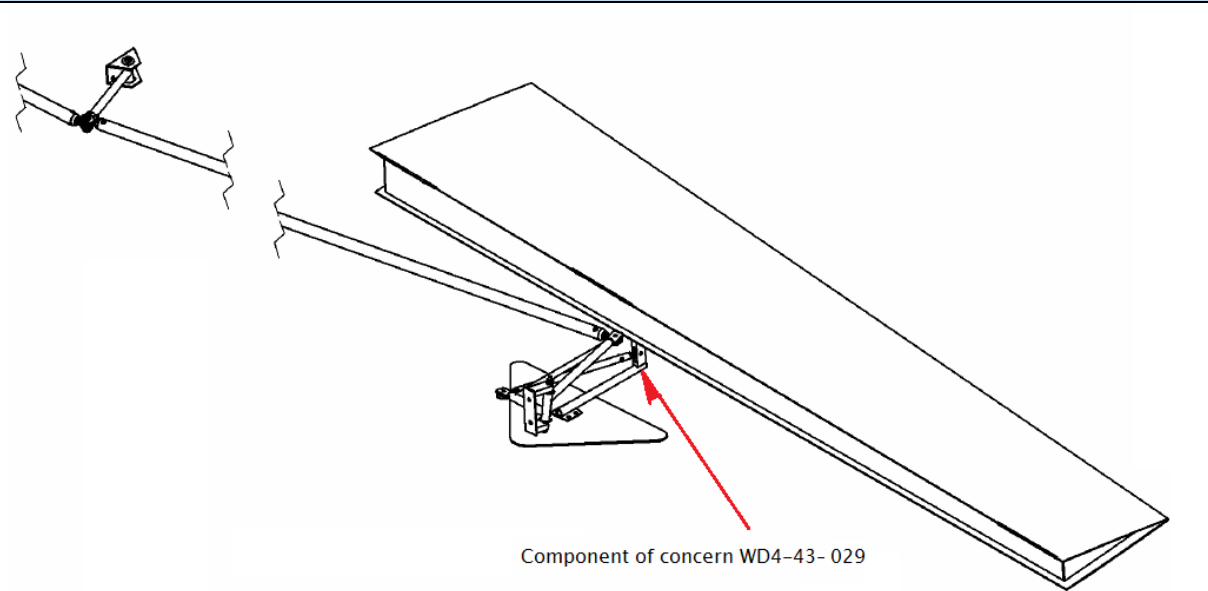
| 2.3) Reason: | Following lethal accident a recent national AD on D4 and D4BK microlight predecessor models was issued concerning the weld of the spade support arm. Although different in design and complying with CS-VLA the corresponding part on the D4 Fascination (VLA) is identified as potential cause of catastrophic failure. |

- A.) Inspect spade support/actuator arm attachment (no free play, no notable flexibility in the attachment area)
- B.) Visual inspect the weld areas for signs of cracks and/or corrosion, ref. Figure 1 & Figure 2.

Figure 1 Area of concern

- D.) If cracks are found the airplane cannot be released to service. In this case contact AD&C for further instructions.
- E.) If no cracks are found and no corrosion is present:

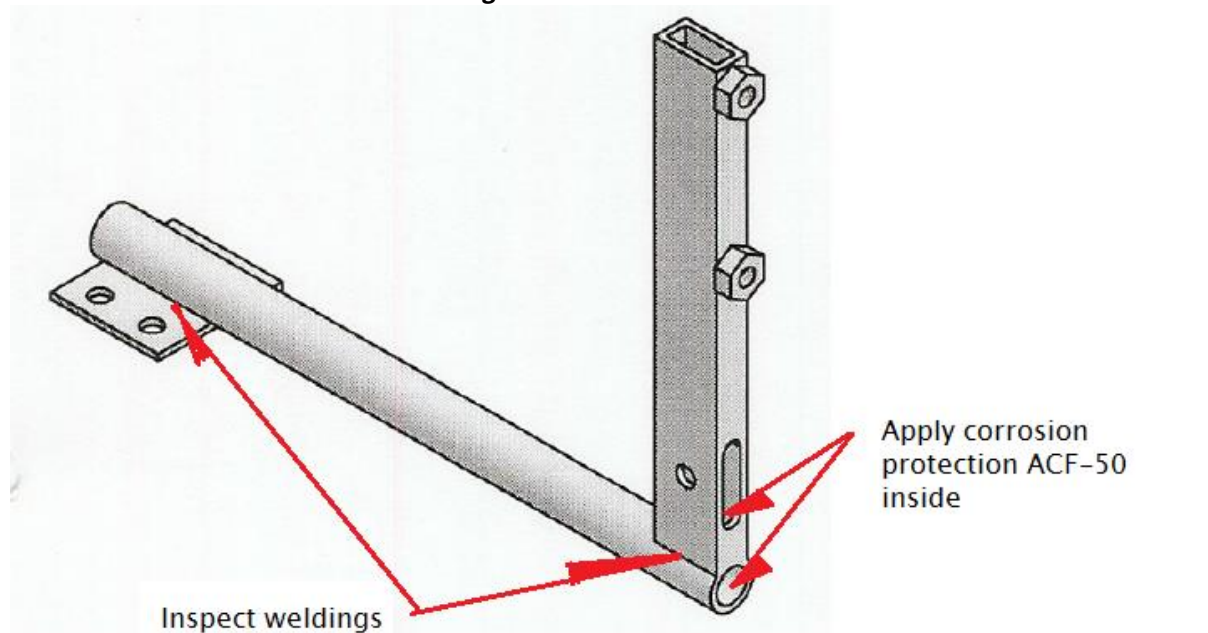
Figure 2 Support arm detail

- C.) Perform dye penetrant inspection on the welding shown in Figure 2. In case of need/doubt remove surface coating (local sanding or sandblasting). Note: removal of the support arm from the aileron is not foreseen as regular maintenance action. In case this is needed contact AD&C for further instructions.

- a. Recoat the support arm as appropriate per chapter 20-10-03 of the maintenance manual.
 - b. Apply corrosion protection "ACF-50" as indicated in Figure 2
